DEPARTMENT OF TRANSPORTATION

Office of Structural Materials

Contract #: 04-0120F4Cty: SF/ALA Rte: 80 PM: 13.2/13.9File #: 74.28**WELDING INSPECTION REPORT****Resident Engineer:**Siegenthaler, Peter**Address:** 333 Burma Road**City:** Oakland, CA 94607**Report No:** WIR-020231**Date Inspected:** 25-Jan-2011**Project Name:** SAS Superstructure**OSM Arrival Time:** 800**Prime Contractor:** American Bridge/Fluor Enterprises, a JV**OSM Departure Time:** 1730**Contractor:** Goodwin Steel, UK**Location:** Trentham, UK**CWI Name:** N/A**CWI Present:** Yes No**Inspected CWI report:** Yes No N/A**Rod Oven in Use:** Yes No N/A**Electrode to specification:** Yes No N/A**Weld Procedures Followed:** Yes No N/A**Qualified Welders:** Yes No N/A**Verified Joint Fit-up:** Yes No N/A**Approved Drawings:** Yes No N/A**Approved WPS:** Yes No N/A**Delayed / Cancelled:** Yes No N/A**Bridge No:** 34-0006**Component:** Cable Band**Summary of Items Observed:**

The following report is based on METS observations at Goodwin International, Trentham, UK on this date.

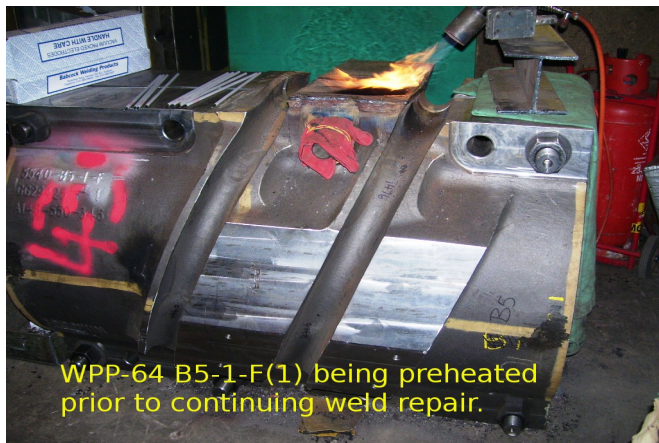
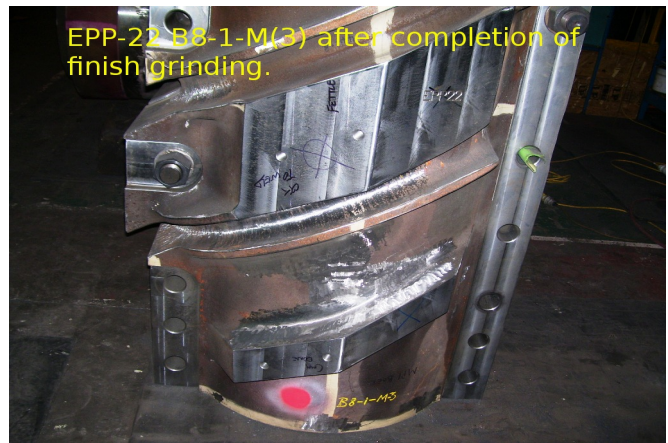
The QA inspector periodically observed that Goodwin International personnel perform finish grinding of an assembled B8 Type 1 cable band for east panel point 22 (EPP-22) consisting of castings 5540-B8-1-M-3, and 5540-B8-1-F-2, and an assembled B9 Type 1 cable band for west panel point 28 (WPP-28) consisting of castings 5540-B9-1-M-7, and 5540-B9-1-F-5. All sharp edges from the machining operations and suspender groove transitions are being ground to required finish by Goodwin International personnel.
